GRAVESTONE CONSERVATION REPORT

ELIZA RODD 1831

ELIZA RODD GRAVESITE CONSERVATION

This report documents the condition of the historic 1831 gravesite of Eliza Rodd, and details possible conservation actions and repairs.

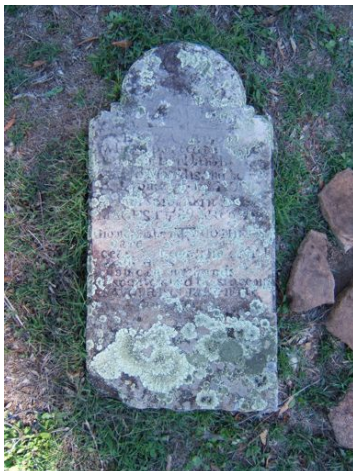
<<The photograph on the left shows the gravesite at a much earlier date. Note that the inscription has been partially painted in.

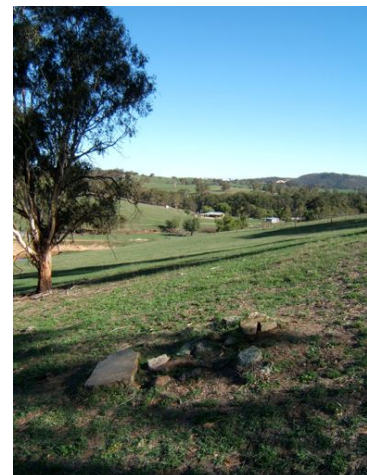
The footstone is broken into three pieces: with the lowest section still installed in its original position, but the top pieces fallen & shifted. Damage could have been from cattle, a vehicle, or a falling object at some point. The stone is, however, repairable and the inscription remains clearly legible (and will become significantly more so when cleaned and maintained). Conservation repairs will be somewhat time consuming and complex, but should improve the longevity of the marker considerably.

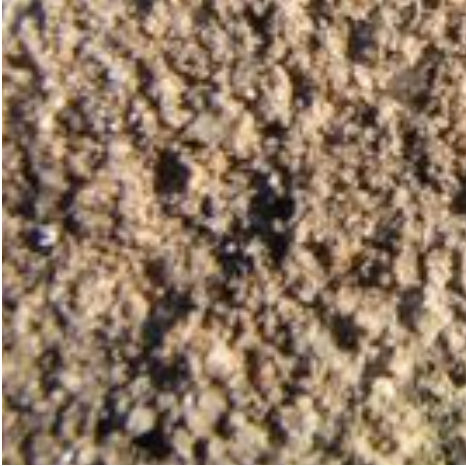
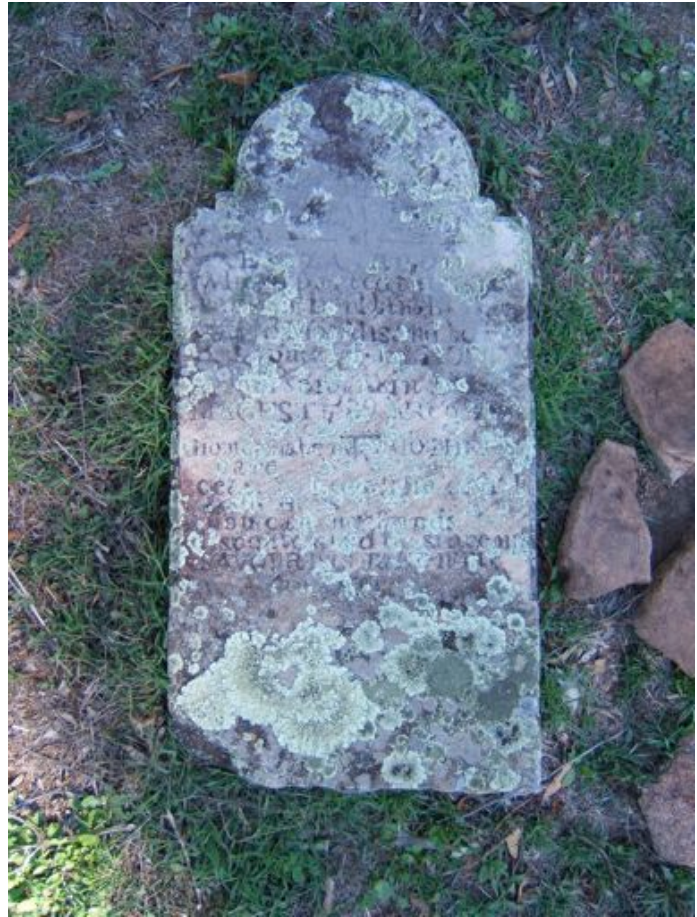
HEADSTONE

The headstone is constructed from a single piece of sandstone which has weathered remarkably well-- especially given that it fell over at some point and has been lying face-up for a considerable time. Although significantly weathered, the stone appears to be solid and stable: with large crystals (likely quartz) held in place by a strong binder which has resisted years of exposure.

1) Gentle hand-cleaning. Biological growths are natural on exposed stone, and generally cause negligible long-term damage. In this case, however, the stone was becoming completely covered over and almost unreadable-- which was affecting its historic value: the inscription is an important part of the surviving significance of this monument. Cleaning should be accomplished with soft natural- or plastic-bristle brushes and clean water. The stone should be pre-wet and then gently but thoroughly scrubbed: with released materials washed off frequently. It is important that the stone not be allowed to dry during the cleaning process. The use of biocides, cleansers, bleach and/or acids is highly discouraged: it is not necessary and could endanger the long-term viability of the stone. [The only treatment which might prove reasonably useful would be a PH-balanced biocide such as the Algicide produced by Keim in Germany. But the reinstallation of the stone in an upright position is much more important and will have a much greater impact in reducing biological growths.] Allowing moderate natural biological growths is consistent with the conservation principle of respecting the history of the stone: it is an old piece of stone installed outside... and there is nothing wrong with it appearing to be such....

January 25th, 2007: An initial cleaning was accomplished by Sach Killam and Marcia Osterburg-Olson. When the stone is reinstalled, a final cleaning should be completed (which can include the back and sides of the stone at that time). The rate of natural biological regrowth will be very much reduced by a vertical re-installation, and so should not pose any further problems for decades.

2) Re-installation: Upright In Original Position. The most appropriate re-installation technique on conservation grounds would be to replicate the original technique: installing the slab into the ground to a depth just below the lowest line of the inscription. This should provide reasonable stability, and is consistent with the last known design. The presence of flat pieces of granite in the area may indicate that the slab was somewhat stabilized by placement of flat pieces of granite around the underground surfaces of the slab. Such a re-installation should not create any new problems as long as the chunks are not too large, so might be justified.

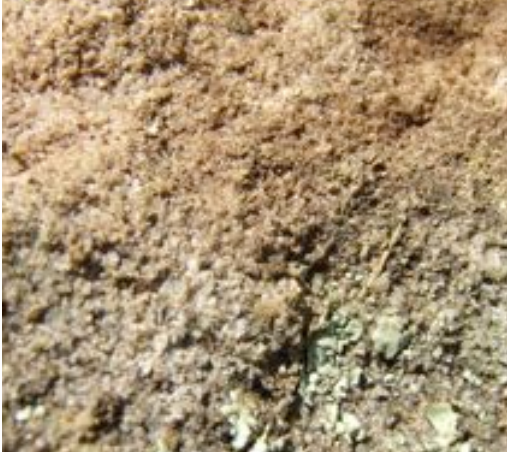
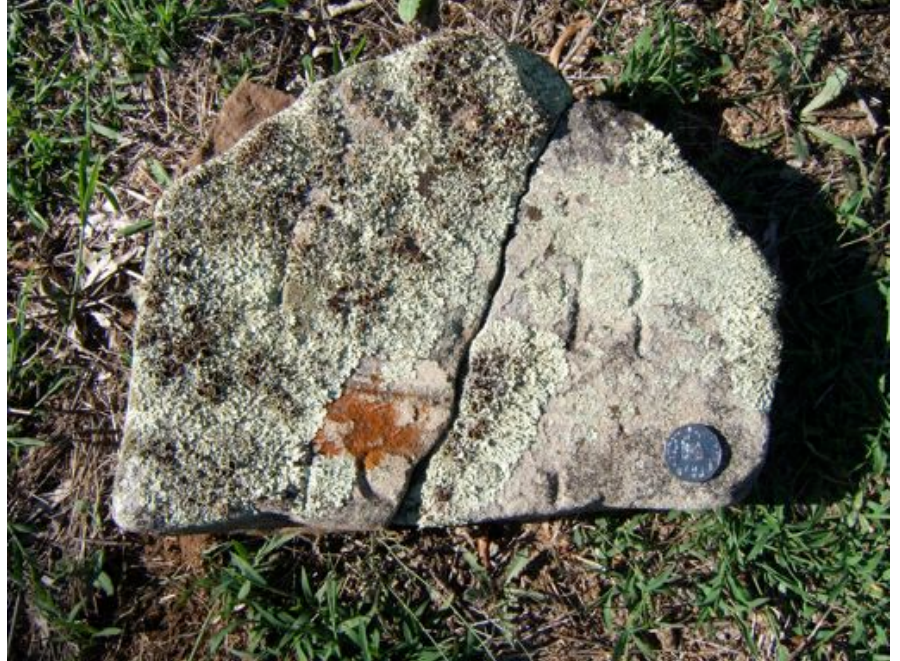
FOOTSTONE

The inscribed footmarker for Eliza Rodd is broken but repairable. The historic sandstone is viable and can be preserved through a conservation hidden-pin repair.

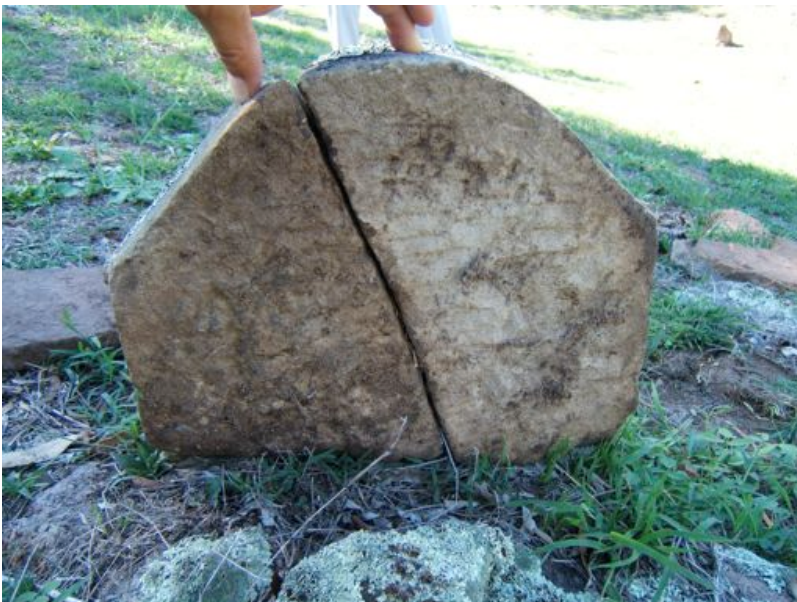
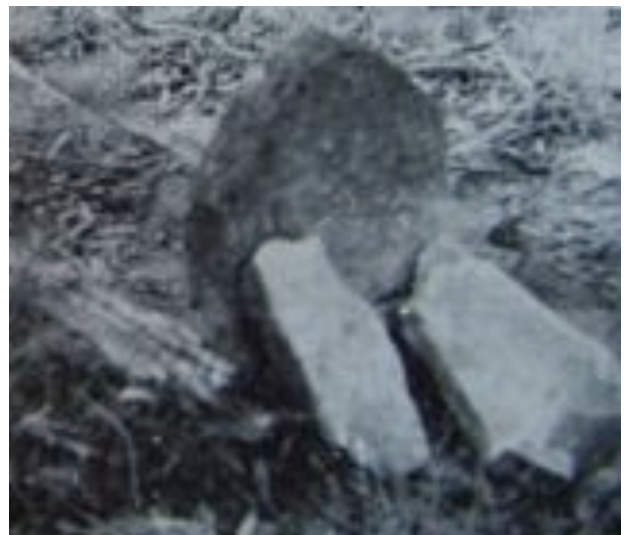
The bottom piece of the footstone appears to be intact in its original position and installation. The two upper pieces fit perfectly onto the existing bottom, and sit at a level consistent with the historic photograph of the stone. The installation matches the siting and landscape that can be seen in the original position. It would seem impossibly unlikely that the location has been altered from that of the photograph: as this would require that the bottom footstone section would have to have been somehow excavated and then reinstalled again perfectly.

The footstone was likely already broken in two pieces at the time of the photograph as can be seen from a dark line at the point corresponding to the current lower break. The presence of a deep and heavily established series of lichens all over the lower break surfaces (but not the vertical upper break) is consistent with this suggestion. The chunks of native granite in the foreground of the historic photo are thus probably a later addition to the design: an attempt to keep the footstone vertically in place. Excavating around the intact bottom piece revealed that it is stable as-is, and is held by a combination of granite sand and buried chunks of granite.

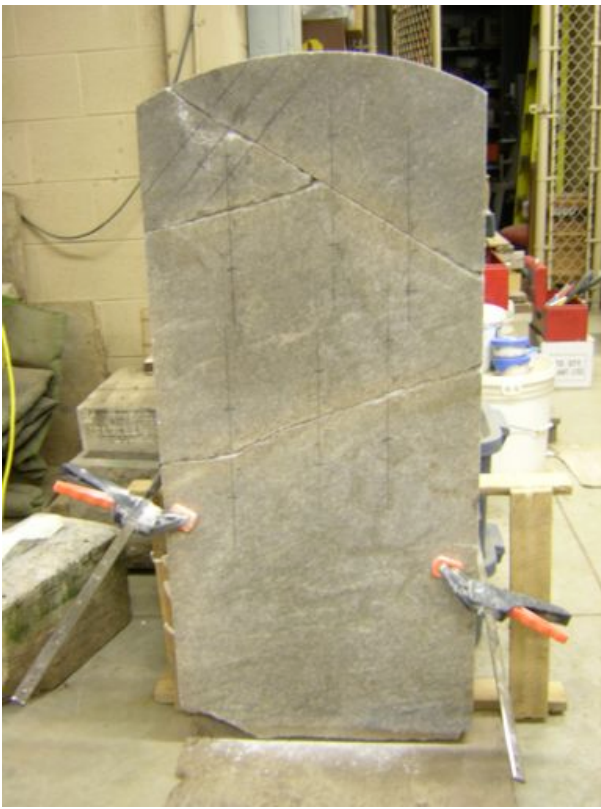
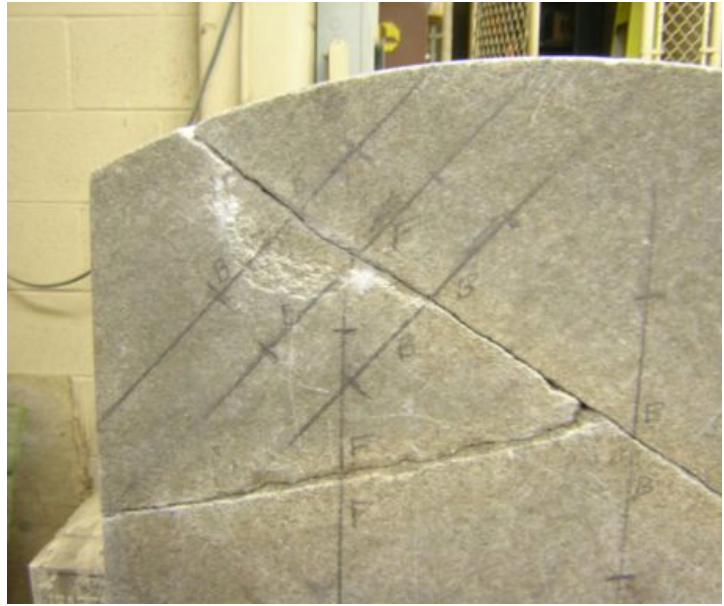
2.2) Measure for Pins. Using a pencil, mark lines for the installation of 3 pins for each of the two breaks. The pins will be installed in an off-set formation. Eventual holes should not be closer than 1.5cm (5/8th") from any surface or edge, so the preferred layout would be for the drill mark to be set at 1.8cm (3/4th") from the edge on the thin sides. Along the break, the pins should be evenly spaced, but tending towards the centre. Note that the holes must be set up such that the pins do not cross inside the stone: particularly front-and-front pins or back-and-back ones... as they may interfere with each other. For a very small monument such as the footstone, the pins will generally need to be 5cm (2") long on each side: ie with a total length of approximately 10cm (4"). See pinning examples on the following page:

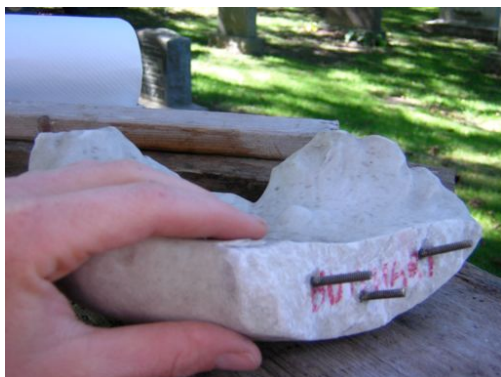
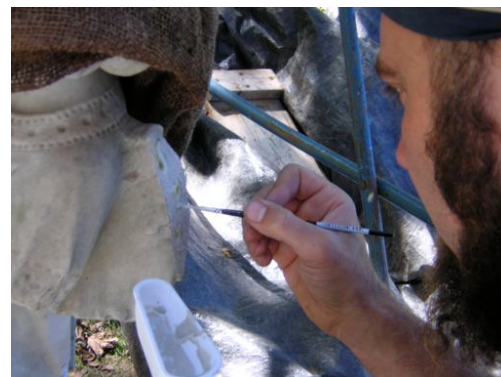
Photo-Two-Step installing repair in

graphs: Repair ready for tion; and, Ap-neat NHL to the process

2.5a) Two-step Pin Installation. The pins along one side of the break are pinned and then allowed to set. After a curing period, the second side is completed. Two-step pin installation is preferable, if time and resources allow, as it can ensure a full epoxy job (especially important if the epoxy has a low viscosity-- or develops a low viscosity in the setting process). Further instructions: the pins and holes must be cleaned and fully dried before use; a gel epoxy with a moderate viscosity and a long working time is preferable; epoxy should be placed deeply into the holes prior to inserting the pin-- a lentula device can be used with hand-turning or a low-speed drill to move the epoxy into place; holes should be half-filled before inserting the pin and have no air pockets (ie the deep half has epoxy, the upper/outer half may have a slight coating but no accumulations); pins should be coated with epoxy and then inserted carefully; no epoxy should come into contact with visible surfaces; a small amount of epoxy will be inevitable around the mouth of the hole-- but excess material should be carefully removed as quickly as possible and before it bleeds into the stone and/or sets. In order to ensure that the pins are installed at the correct orientation, it is often valuable to brace the initial pinning side upright and then have the epoxy set with the pins in position. Note that there must be NO excess epoxy in or around the pins and joint as, otherwise, the pieces can be inadvertently bonded together. Similarly, the pins can cause a serious problem if they are not parallel (or, at least, very close to parallel.) as they will hold the un-epoxied second side in place accidentally. Obviously, the pinning process requires patience, experience, and thoughtful care. Once the first side has set (and it is best to allow the epoxy to reach a near-full strength-- often 24 hours or so), the pins can be checked against the holes on the opposite side. Any holes which require reaming can then be enlarged (see 2.4). The second side of the pins can then be completed using the same technique but with the addition of clamps to hold everything in place during the setting process. Caution must be used to ensure that the clamps are as tight as possible WITHOUT causing any stress to the stone OR deformation OR slippage-- the latter can be quite tricky and may involve the use of angled shims.

In both cases, if the open break joint is perfectly tight, it can be treated with neat Natural Hydraulic Lime during the pin-setting process. Lime mortar would still be used on any open and accessible joint areas: but, especially with the break between pieces 2 & 3, the space between the stone may be too small to access effectively. Similarly, mortar can be placed in the joint during the final pin-setting, but this is very difficult to complete correctly: as any excess mortar in ANY place within the break will compromise the repair. [These techniques are thus suitable only when highly experienced practitioners are completing the repair. Note also that a two-stage pinning process is also recommended for each repair if the open joint is being treated, as it reduces the complexity of the latter part of

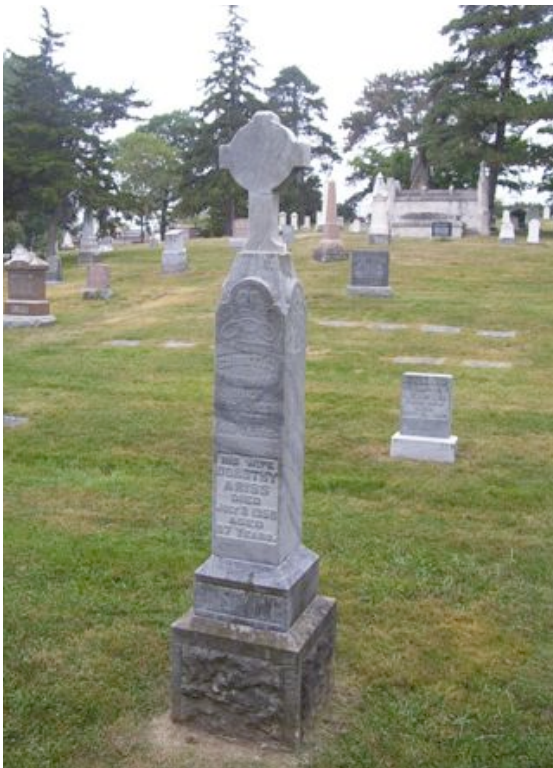
A lime putty mortar joint for a hidden-pin repair (Repair 1999, Photo 2005).

2.7) Lime Mortar. Once all of the pins have set (refer to information from the epoxy supplier: usually 24 hours), the monument should be gently tested. There should be no noticeable movement under reasonable pressure. If the pinning work has been successful, the joints can then be repaired with a lime mortar using no portland cement (neither white nor grey). A full discussion of the techniques and advantages of lime mortars is beyond the scope of this report (See References for more complete information), but key points include that, if properly prepared, the mortar will be slightly softer, more flexible, and slightly more porous than the stone. This will help to ensure that future damage occurs in the mortar and not in the historic gravemarker. The lime mortar should also be self-healing if minor cracks develop. All of these properties, however, depend on the correct preparation, installation, and aftercare of the lime mortar. At Woodlawn, a 1:1:5 mix is generally used for similar monuments: 1 part lime putty, 1 part Natural Hydraulic Lime, and 5 parts aggregate (a well-graded mix ranging from microfine stonedust to fine (seived) or medium sand: angular and sharp). As an alternative, a mortar could be prepared from lime putty gauged with a pozzolan: in a 2:1:7 or 3:1:9 proportion (lime putty, pozzolan, aggregate) with a similar sharp and well-graded sand. If Natural Hydraulic Lime is not available, the gauged pozzolan mix might be the only option. Westox is an Australian supplier for both lime putty and for a premixed coarse stuff (lime putty with sand) accompanied by a pozzolan. [I have not yet tested their products, but they appear to have a thorough knowledge of lime and lime products.] Preparation of the mortar is through a combination of beating, chopping, and kneading: it is not simply a mixing process (like cement). The lime must be crushed into the smallest available spaces. No water should be added to the mortar: it will emerge during the beating and kneading (from inside the lime putty and the NHL, prepared as per its instructions, if applicable. In dry and windy conditions, it may be necessary to add a few spritzes of water from an atomizer to replace evaporated water. The mortar will be slightly crumbly but hold on to a knife if pressed in and lifted out. Application of the mortar must be to a clean surfaces which have been thoroughly pre-dampened (though without any standing or pooling water). The mortar should be firmly placed into joints using as small a tool as necessary (strong forks which have been ground down to a single tine can make good applicators). The mortar must not be allowed to dry out while the job is being completed: protect it from direct sunlight and spritz with water regularly as necessary-- or cover completed areas with damp burlap (hessian). When the mortar is completely in place, the surface should be finished by pounding it with a strong short-bristle brush. Lime mortar should not be smoothed: it must have a rough and open surface to function properly.

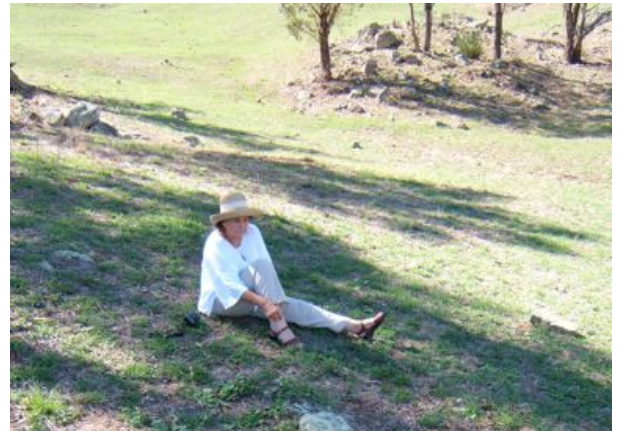
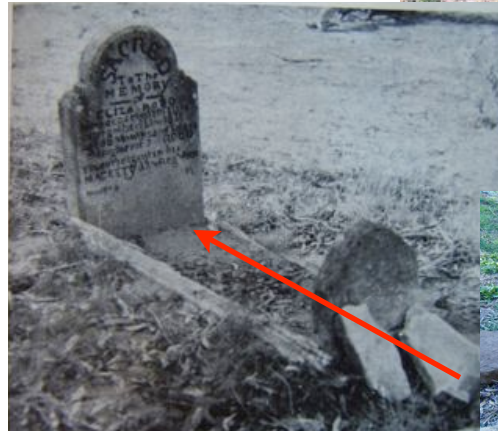
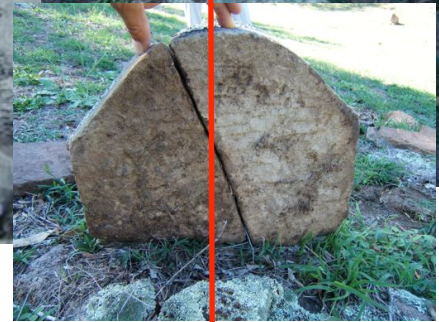
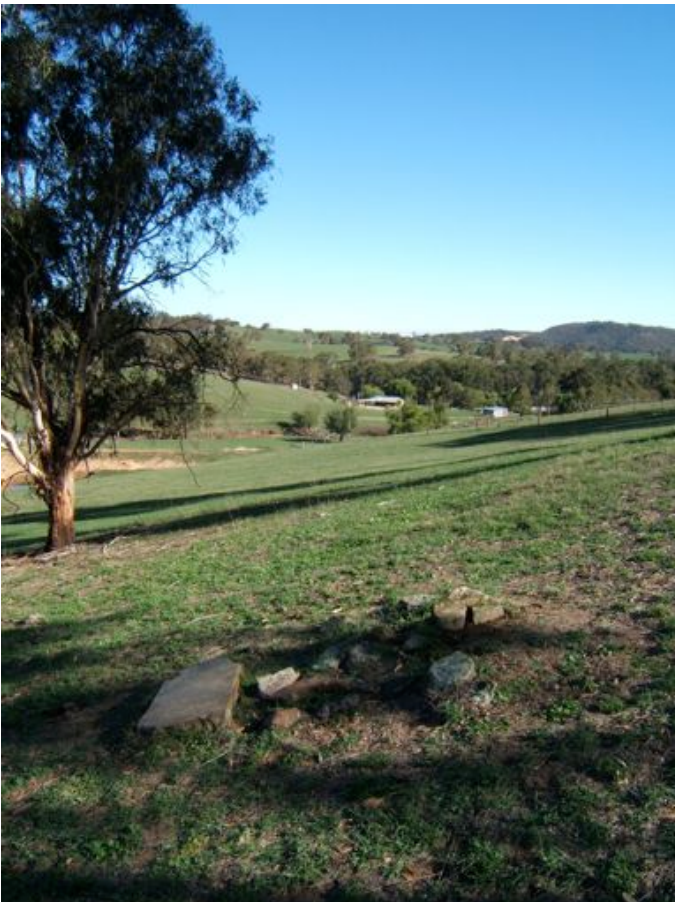
A comparison of the current location of the intact in-ground footstone piece with the apparent background of the historic photograph seems to show that the footstone is indeed in its original location. It would be almost impossible for the surviving in-ground footstone fragment to have shifted and then somehow been reburied to just the right height and orientation by accident. It might be possible, however, that the memorial was moved or reinstalled in an incorrect location at some point prior to the historic photo. That the current site is the correct one, however, is a reasonable conclusion on the basis of the available evidence. Further research could be undertaken with ground-penetrating radar or a similar technology if necessary.

Comparison: The end of the right arrow is the base of the footstone. The angle corresponds with that drawn over the historic photograph: with the ground falling away at a significant but gentle slope to the right and ahead.
